JPL PUBLICATION 84-58

Alternate Nozzle Ablative Materials Program

N. A. Kimmel

September 1, 1984

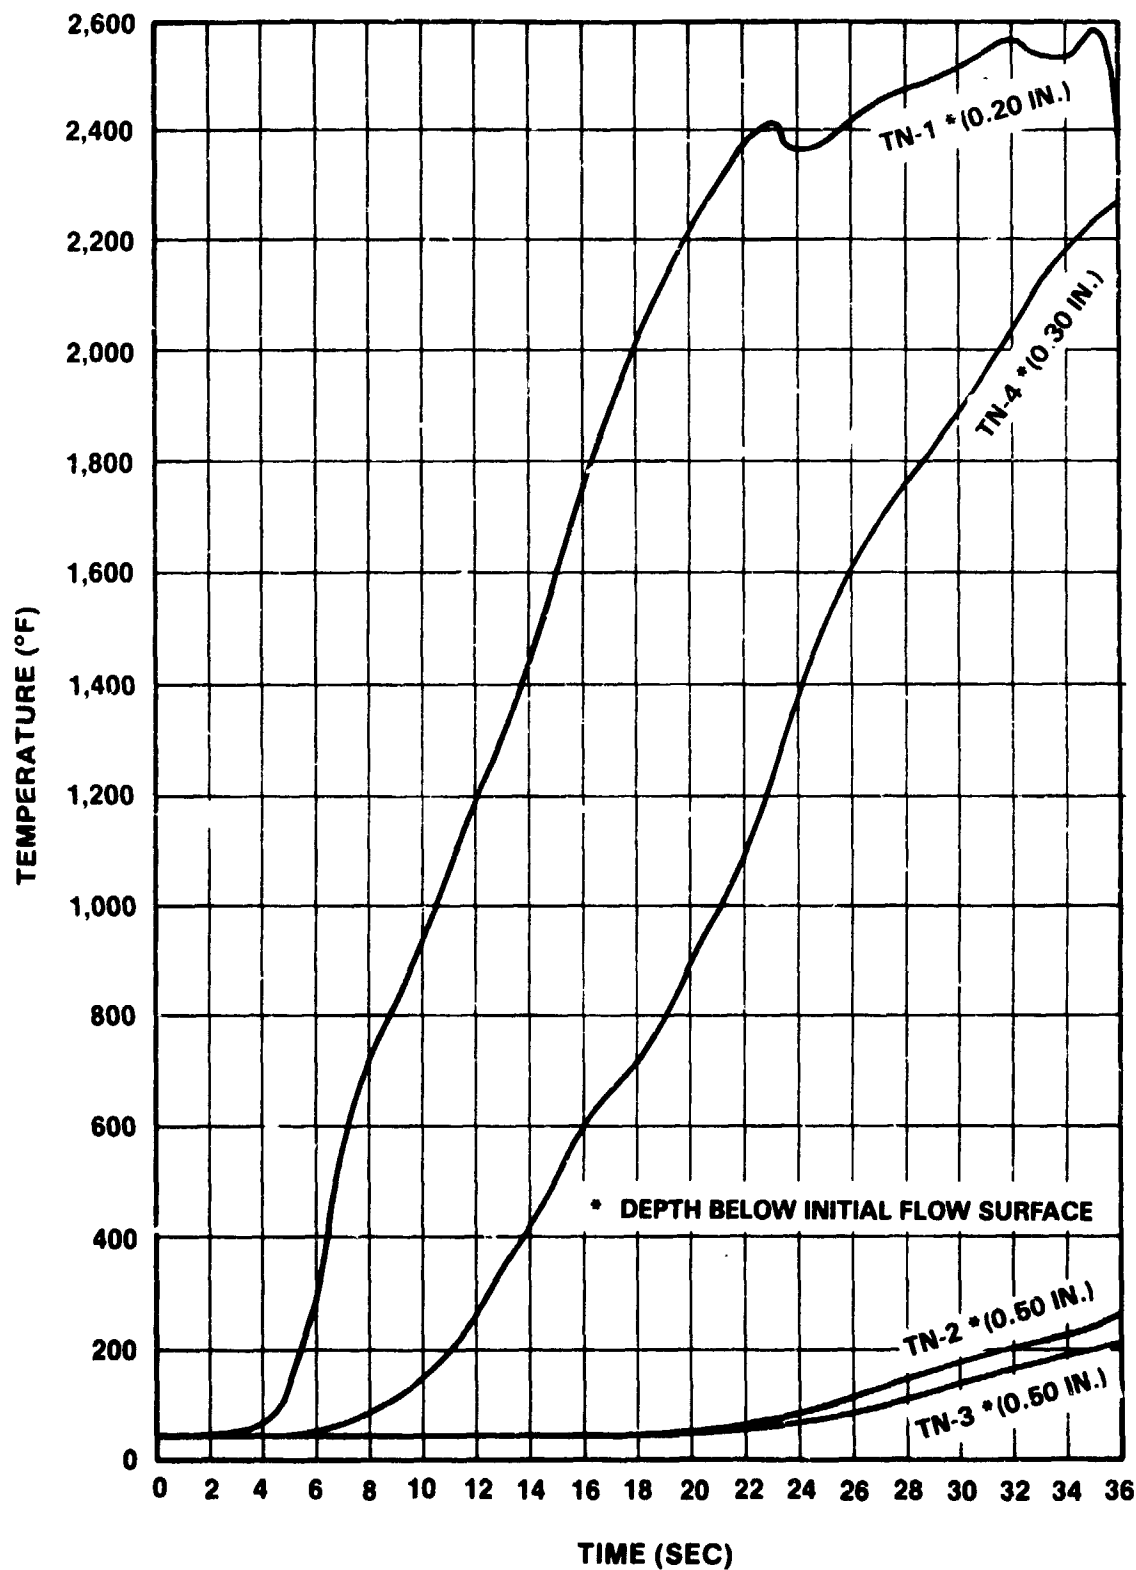
Figure 16. N-2 Nozzle Thermocouple Data

Just prior to testing, all thermocouples read 40°F. The initial temperature rise for the shallower thermocouples, TN-1 and TN-4, occurred at $T + 4$ and $T + 6$ sec and continued to rise throughout the test. Temperatures of 2,590°F (TN-1) and 2,270°F (TN-4) were recorded at 36 sec. TN-2 and TN-3, the deeper thermocouples, showed a gradual temperature rise over motor burn time. TN-3 recorded a temperature of 205°F at 36 sec, and TN-2 recorded a temperature of 260°F.

The peak temperatures of TN-1 and TN-4 indicate these instruments were within the char depth of the material; char formation in phenolic is generally defined as occurring within a temperature band of 800° to 1,000°F. TN-2 and TN-3 were experiencing heating but were still below the charred region of the material.

A comparison of the thermocouple data from the baseline rayon material and the PAN materials tested in the N-2 nozzle shows the PAN materials to be much hotter. At 0.3 in. from the surface the baseline temperature was 900 to 1,000°F compared to 2,270°F for the PAN material. At a 0.5 in. depth the comparison is 100°F for the baseline and 200° to 260°F for the PAN material.

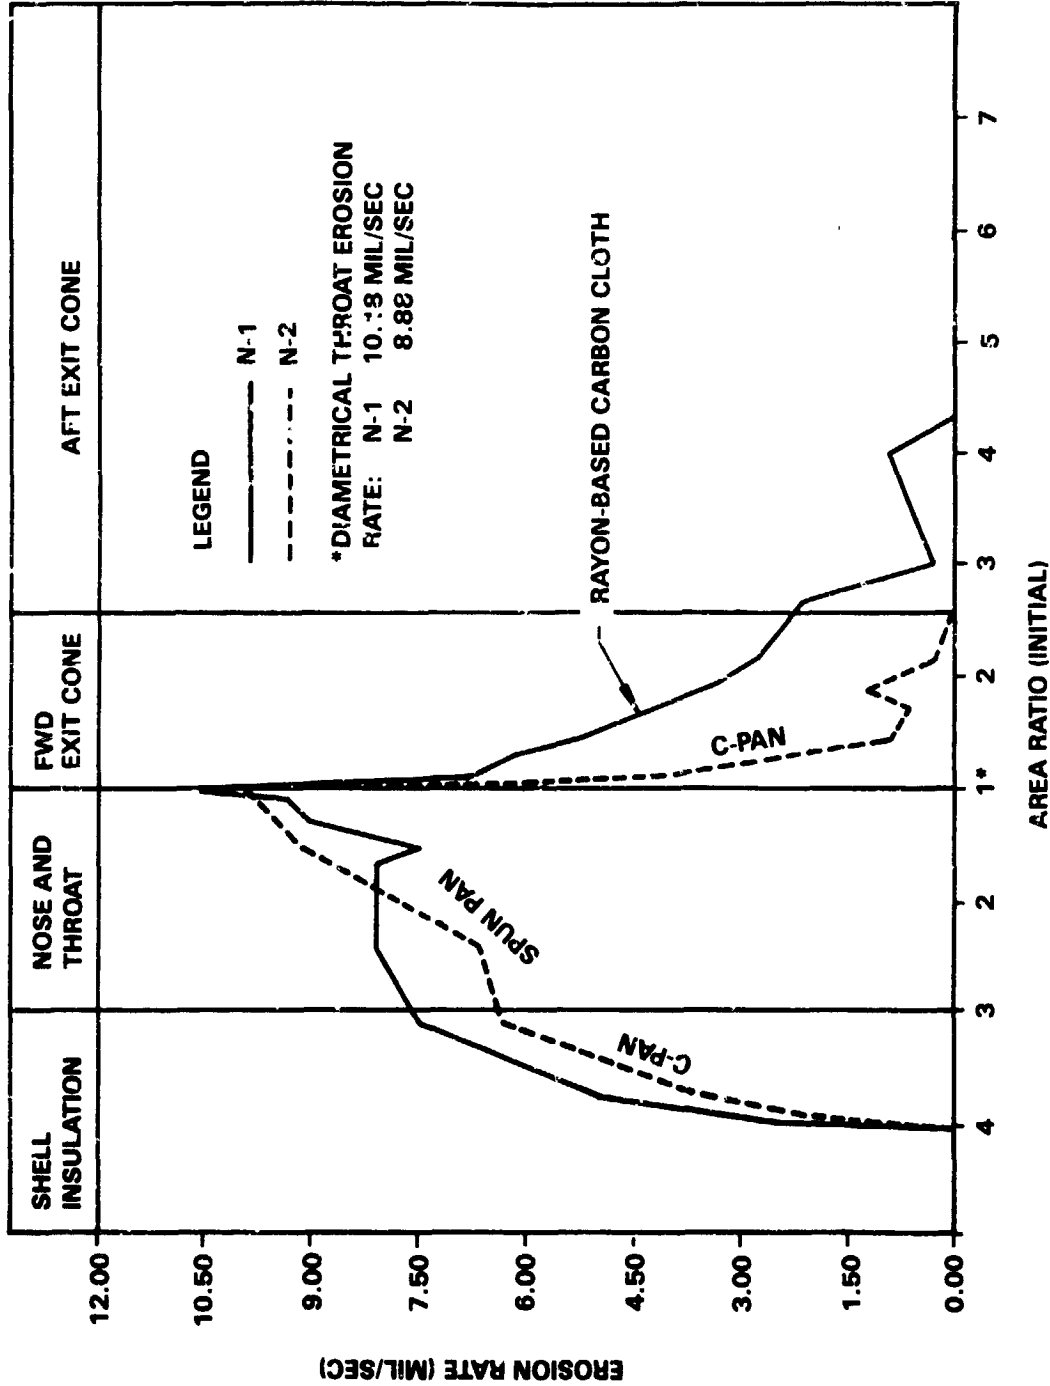
Figure 17. Erosion Rate vs Area Ratio Based on Nozzle Cross Sections

A comparison of the N-1 and N-2 nozzle erosion rates as a function of initial area ratio, is presented in Figure 17. These data are based on an average of four cross-sectional erosion measurements. Erosion data in the aft portion of the aft exit cone are somewhat questionable due to material swelling and some localized spallation.

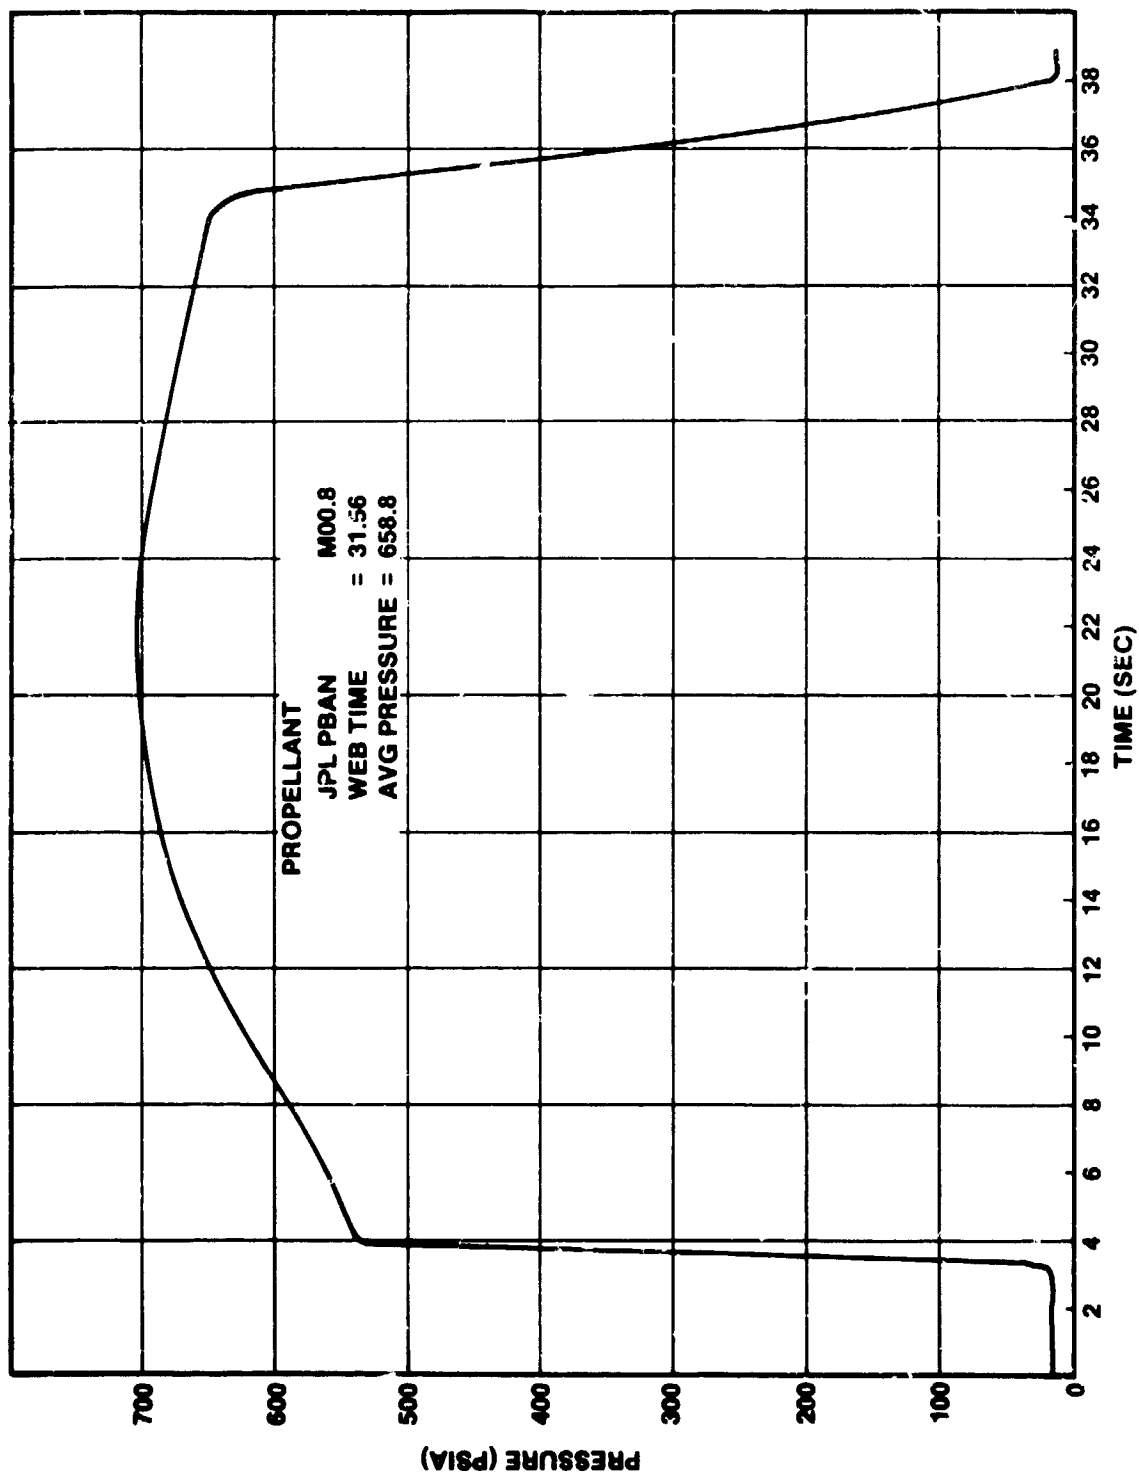
Figure 18. Motor Chamber Pressure

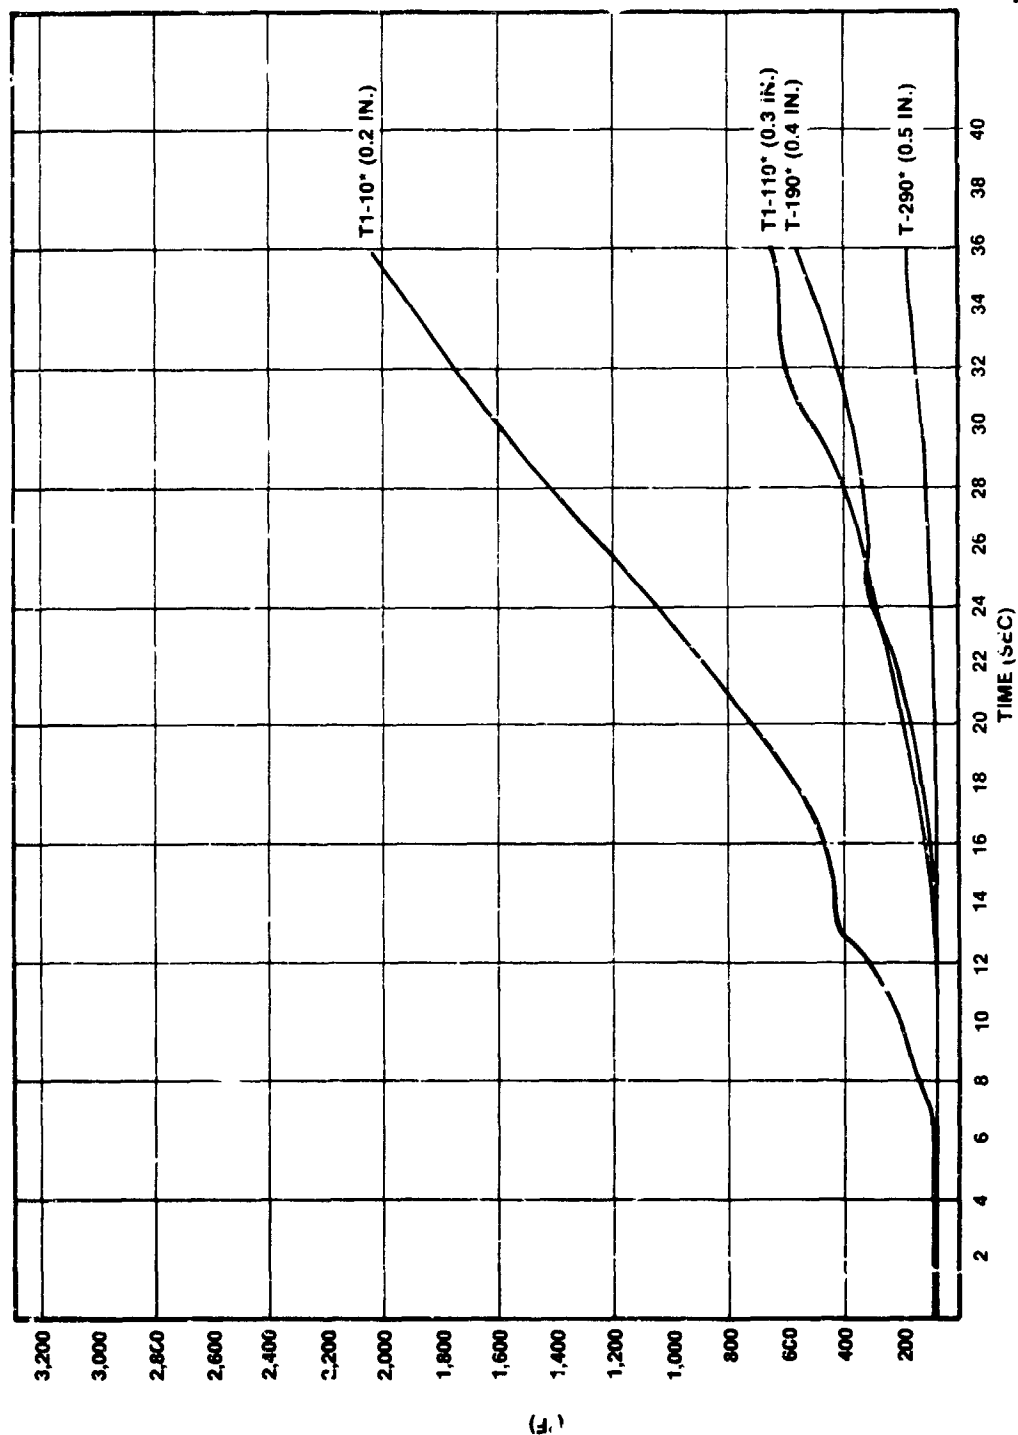
Figure 21. N-3 Nozzle Thermocouple Data

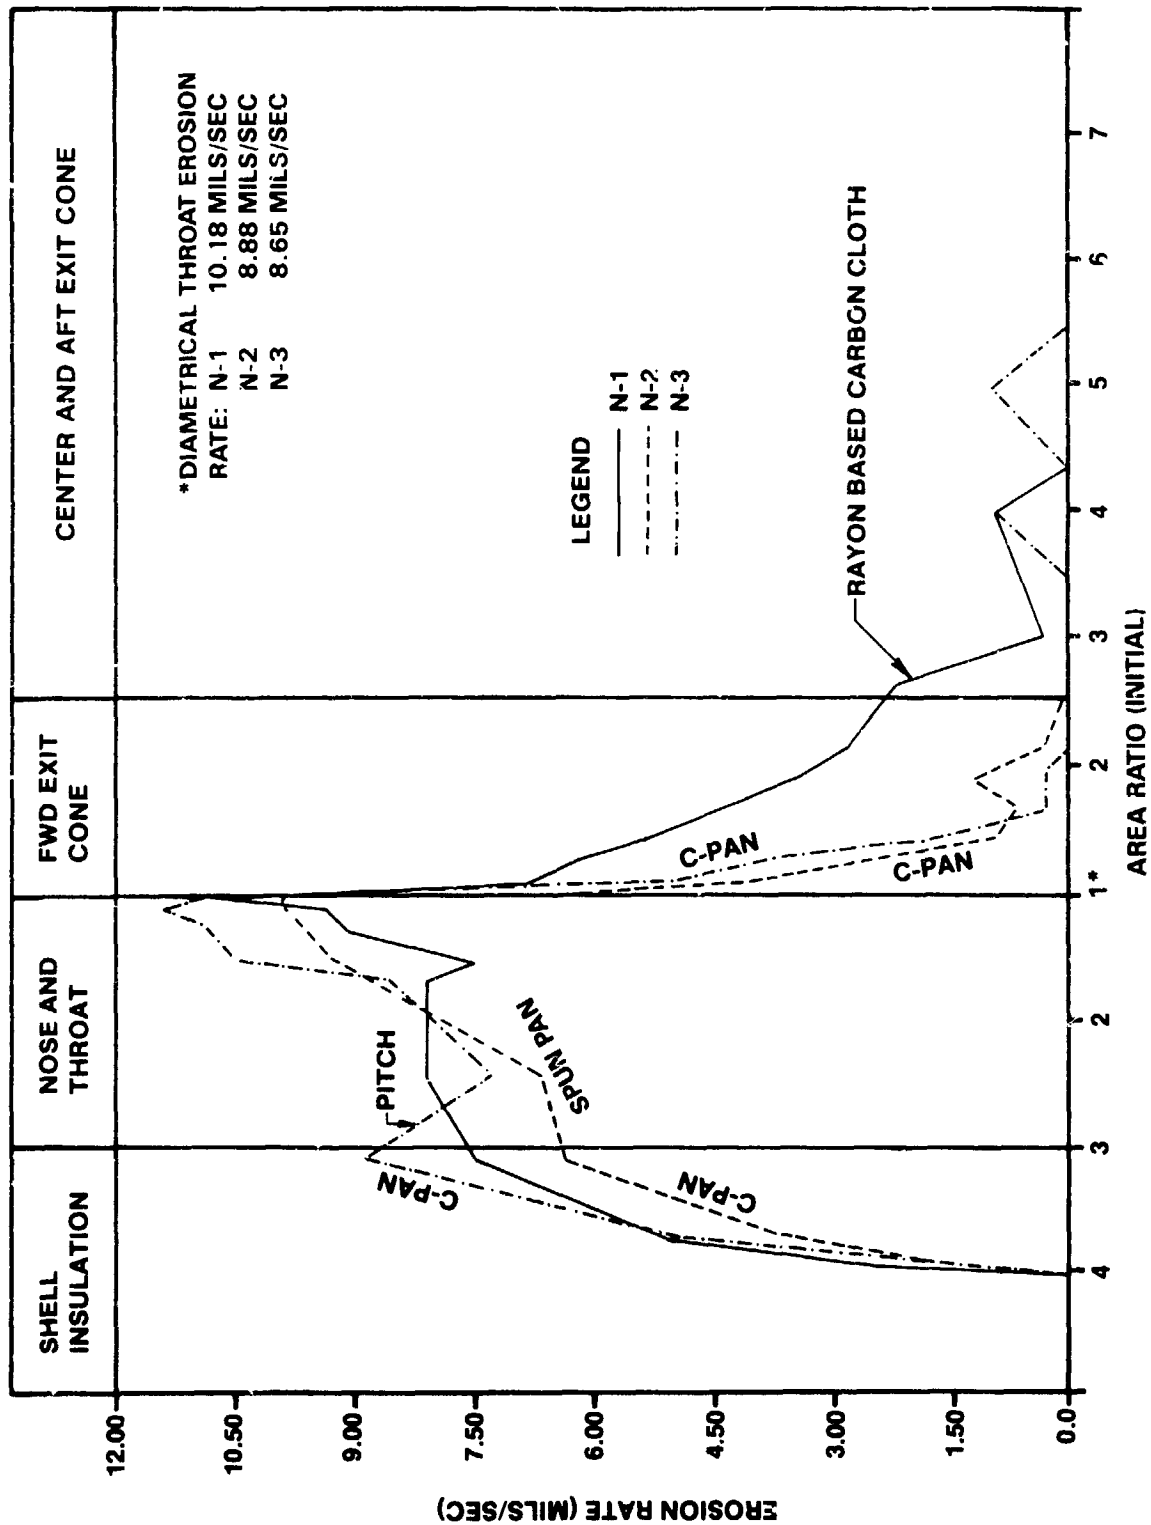
Figure 22. Erosion Rate vs Area Ratio Based on Nozzle Cross-Sections

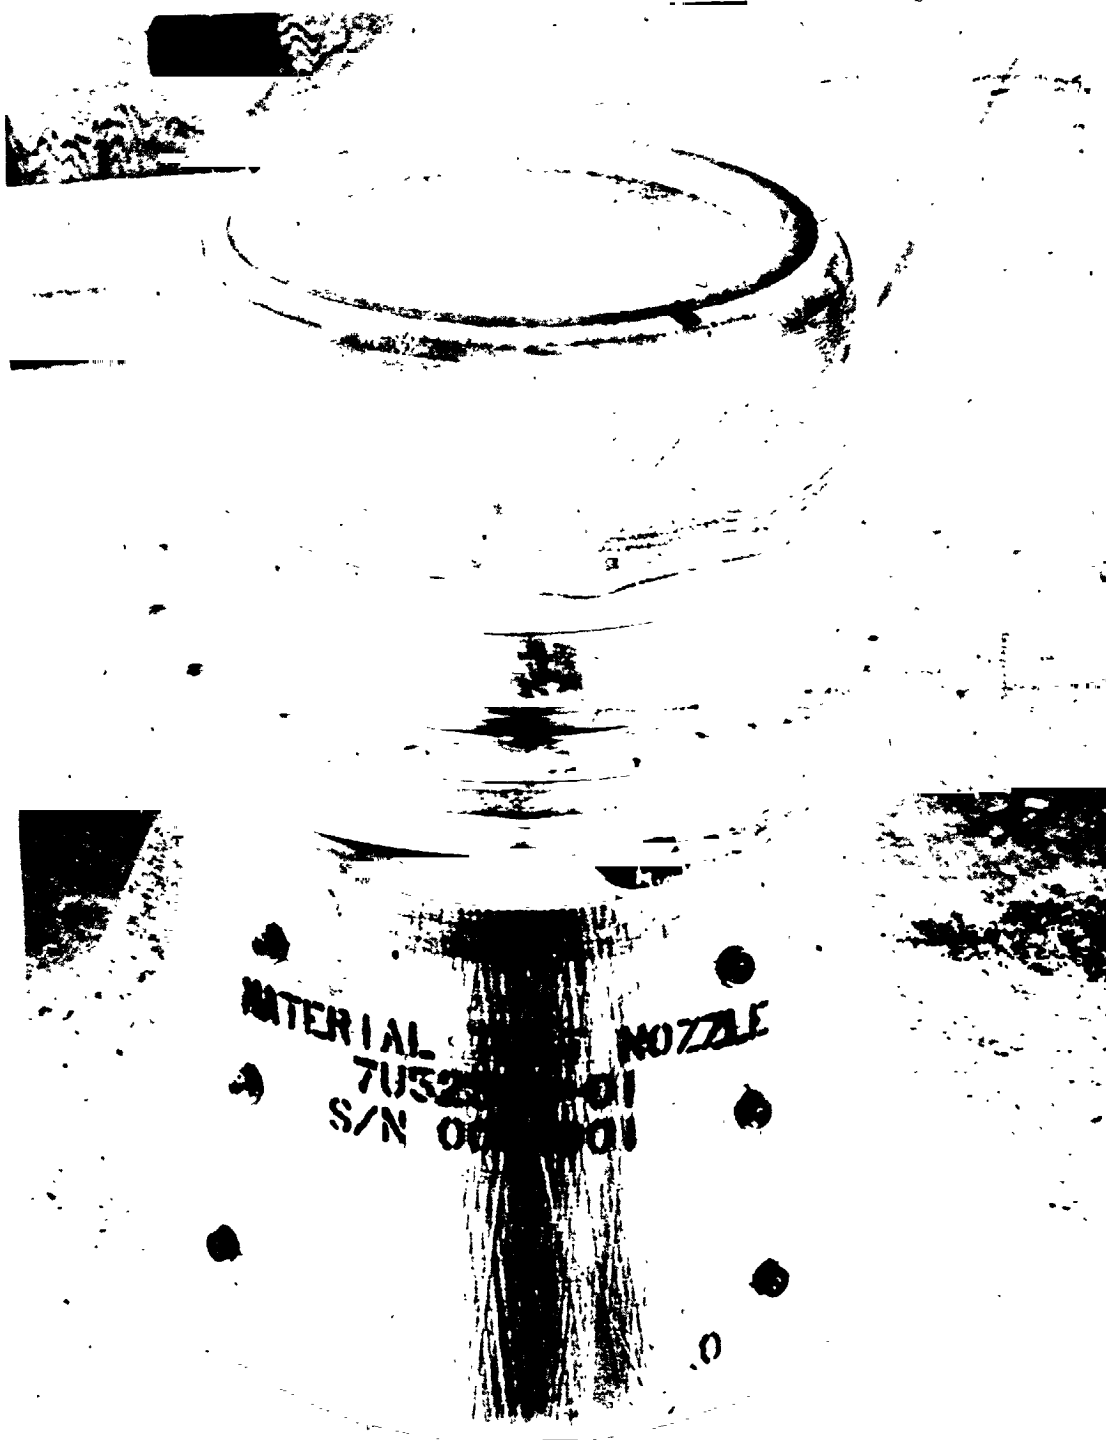
Figure 9. N-4 Nozzle Post-Test

The overall performance of the N-4 nozzle was good. Erosion was smooth and uniform. No major anomalies were observed. The nose, throat, and forward exit cone showed excellent integrity with very even erosion and char profiles.

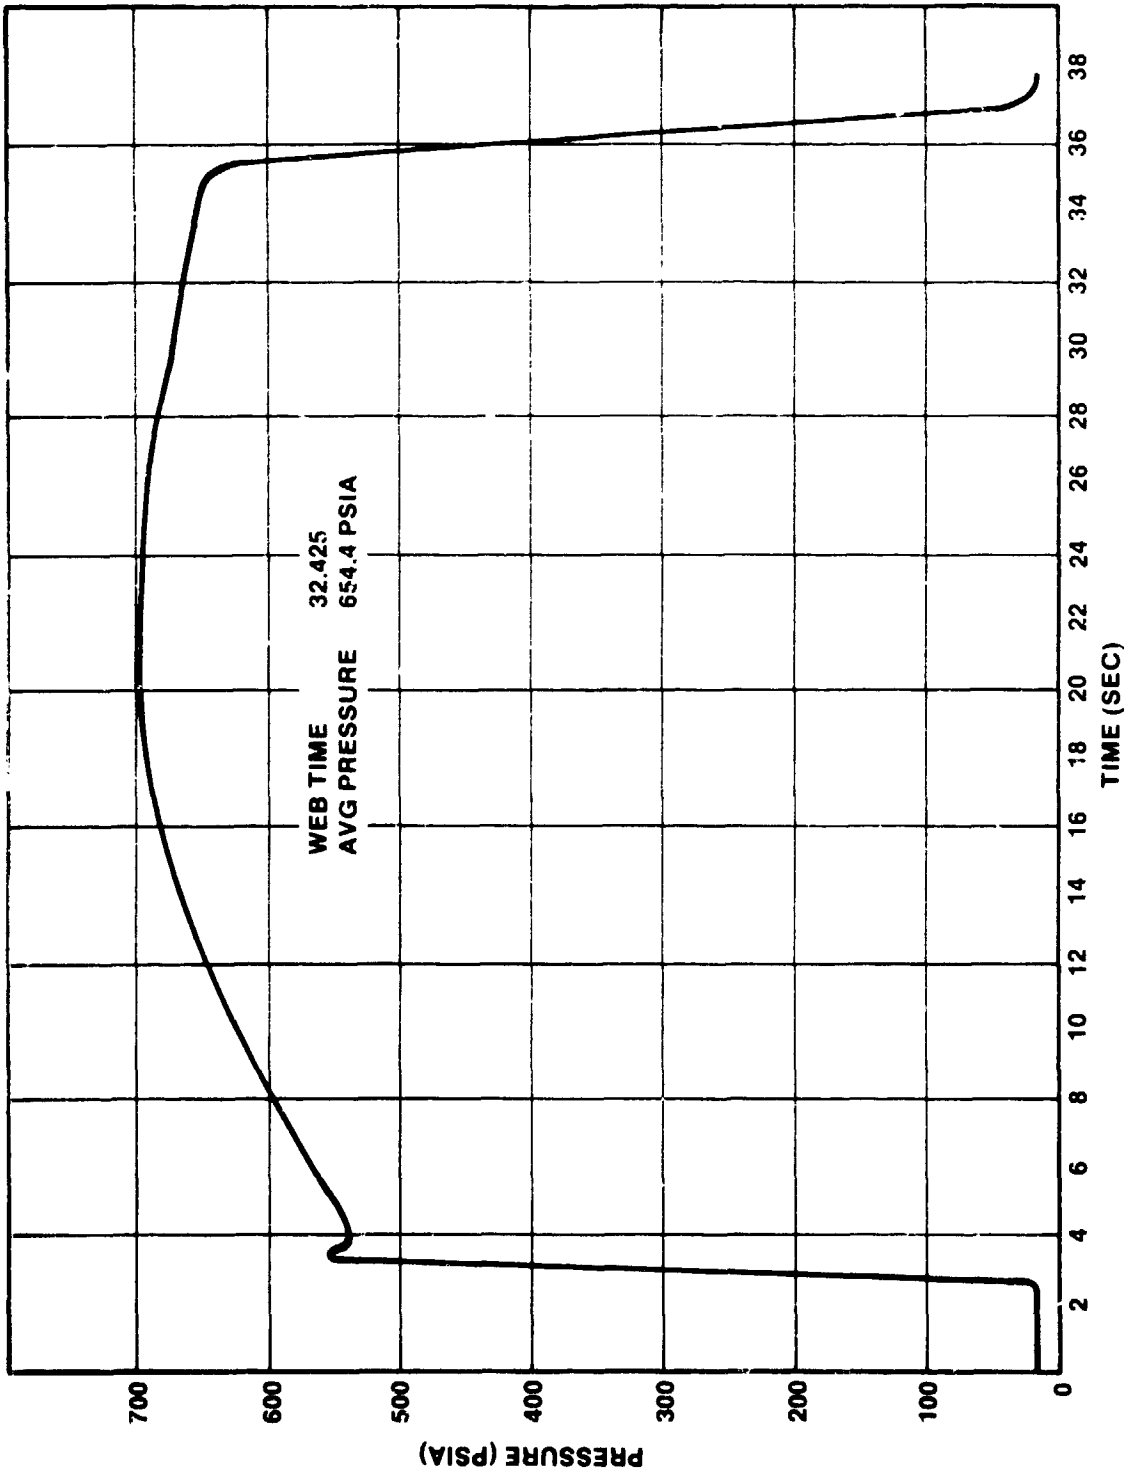
Figure 23. Test N-4 Motor Pressure-Time Curve

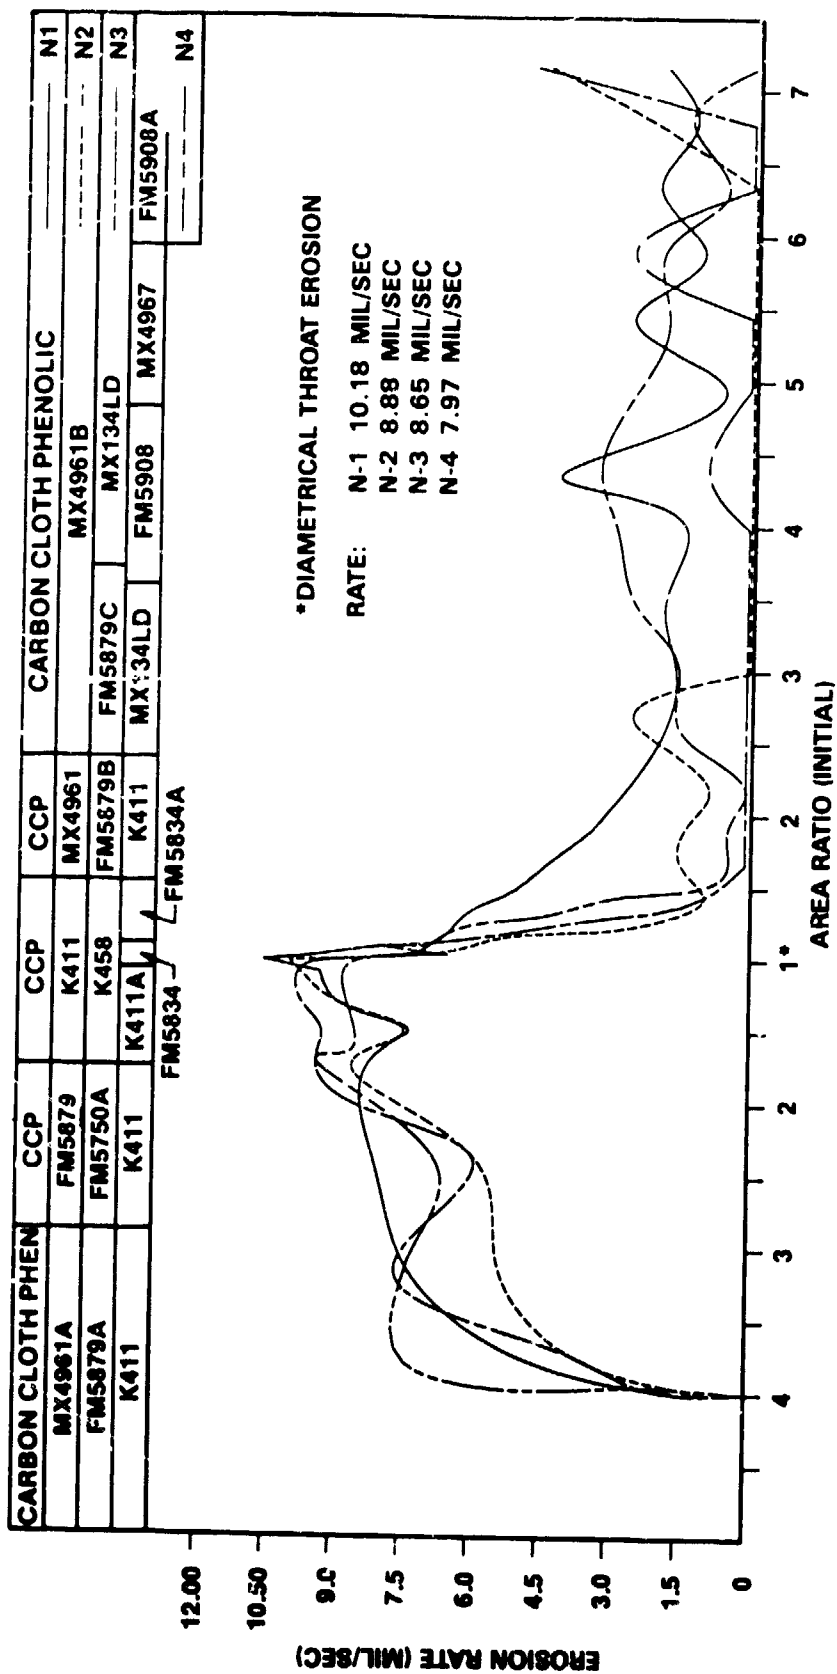
Figure 30. Erosion Rate vs Area Ratio Based on Nozzle Cross Sections

Erosion in the exit cones varied between 0 and 4.5 mil/sec and was variable down the cone. It appears that the continuous PAN, baseline material, and low density materials eroded approximately the same in this environment.
